QUALITROL CASE STUDY:

SERVERON™

ACETYLENE: HOT METAL GASES

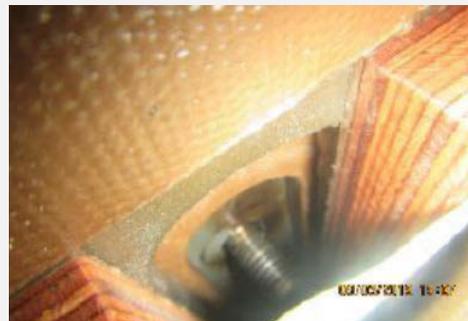
The transformer was inspected on site by the manufacturer and it was identified that a loose nut on the PA Core Leg Phase 1 resulted in an area of overheating (Figure 1).

Figure 1: Loose nut on PA core leg phase 1

Repair was affected by replacement of the PA unit following careful inspection of threads for damage and the application of the correct torque to the nut.

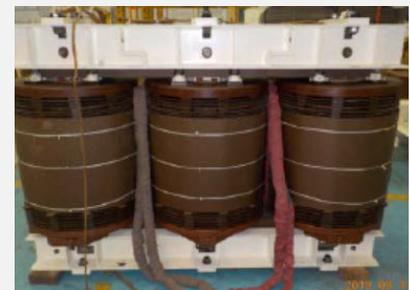
Figure 2. PA after being removed from tank

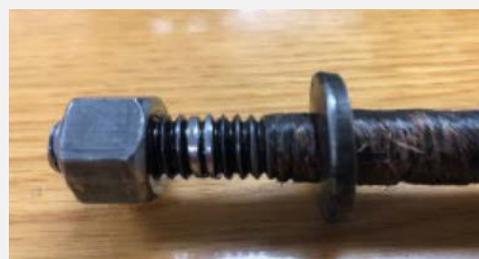
Upon returning the transformer to the factory for repair (Figure 2) it was further discovered that the nut had screw thread damage which resulted in the correct torque being applied during manufacture not actually tightening the nut sufficiently (Figure 3).

Vibration in operation had caused the nut to loosen and disassemble.

Figure 3: Image of offending bolt/nut assembly showing thread damage
